STRAIN ANALYSIS OF HMMWV FRONT LIFT PROVISION

March 1989

US ARMY
LABORATORY COMMAND
MATERIALS TECHNOLOGY LABORATORY

REPORT DOCUMENTATION PAGE		READ INSTRUCTIONS BEFORE COMPLETING FORM
1. REPORT NUMBER MTL TR 89-24	2. GOVT ACCESSION NO.	3. RECIPIENT'S CATALOG NUMBER
4. TITLE (and Subtitle) STRAIN ANALYSIS OF HMMWV FRONT LIFT PROVISION		5. TYPE OF REPORT & PERIOD COVERED Final Report

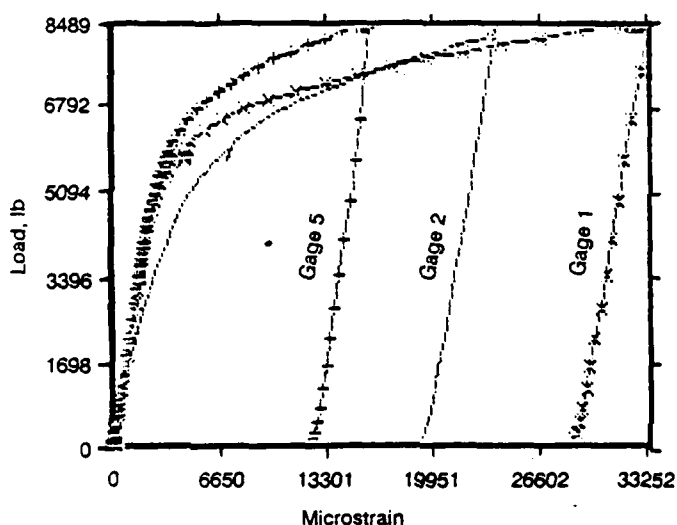
Figure 6 shows the load-strain data for three of the strain gages for the first pull of the provision tested at 8650 lb/20 degrees. Upon unloading, it is obvious that permanent strain has resulted. The largest plastic strain measured, 2.9 percent, was found at gage number 1 (Figure 1), and all of the gages showed some signs of plastic flow. Gage number 3, directly above the loading point, experienced approximately 1-percent strain before the gage debonded. This provision was visibly deformed.

Figure 6. Load versus strain data for the initial loading of a provision to 8650 lb at 20 degrees. Gages correspond to Figure 1.

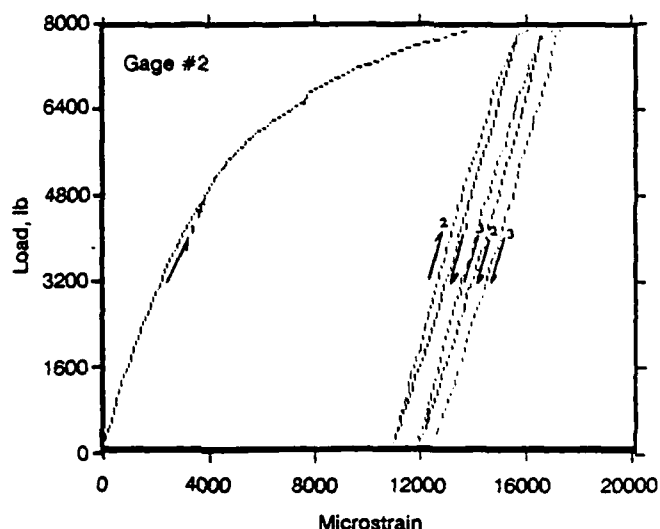
The provision loaded to 8,000 lb at 10 degrees also showed plasticity from the strain-gage measurements. The largest measured strain was 1.09 percent at gage number 2. Again, all five gages measured some permanent deformation, and gage number 3 debonded. Visual inspection of this provision to detect permanent set was inconclusive.

The second and third pulls on these provisions causes only small increases in the total (accumulated) plastic strain because of work hardening. For example, the plastic strain at gage number 2 of the 8,000-lb/10-degree specimen increased from 1.09 percent to 1.27 percent after the third pull. This small increase in accumulated strain was not visually noticeable. Hysteresis was seen in the load-strain data. Figure 7 shows the load-strain response for gage number 2 in the 8000-lb/10-degree test for all three loadings.

Figure 7. Load versus strain data for gage number 2 for loadings 1, 2, and 3. Provision was loaded to 8000 lb at 10 degrees.

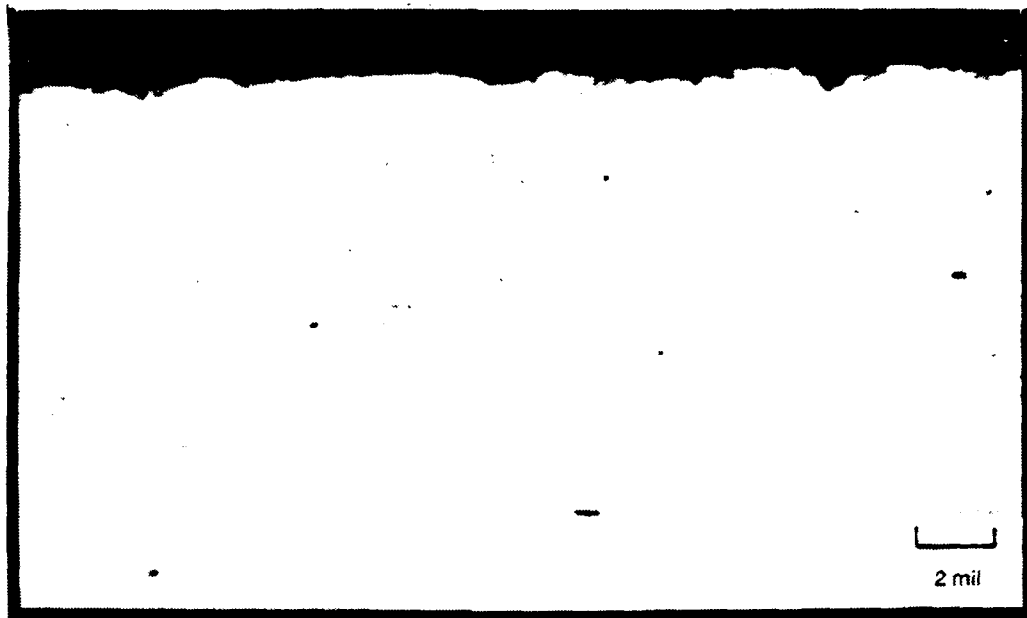
These statically-tested provisions were sectioned near each strain gage for metallographic analysis to detect flaws introduced by the static tests. Figure 8 shows a section at the outer surface. No unusual flaws or cracks were detected in either provision.

Figure 8. Section of provision tested statically to 8650 lb at 20 degrees. No unusual flaws or cracks are seen. Unetched.

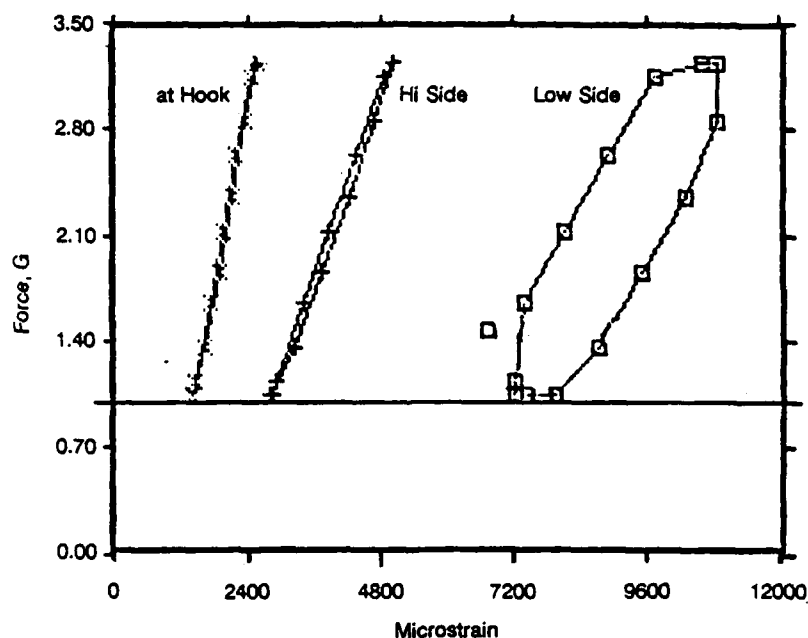
The load-strain behavior of the provision during the fatigue test is typified by Figure 9. In this figure, the strain-gage response for the fourth 3.2G cycle (the 2422nd total cycle) is given. Because of possible gage debonding, the accuracy of data from gage number 3 is in question. Hysteresis in the plastic strains measured indicate that low cycle fatigue processes may be operable when the provision is cycled to the 3.2G load.^{4,5} Data for the 2.5G level are similar, but indicate even smaller levels of reversed plasticity. No hysteresis is apparent for load cycles that only reach the 1.75G loads, whether pulsed or ramped loadings were used. This provision withstood 18,810 total cycles of the NRDEC prescribed loadings.

Figure 9. Typical load versus strain data taken during the first long term fatigue test. Data shown are for the 3.2G load cycle, total cycle number 2,422. Hysteresis is seen in the data for gage number 1. Low side is gage 1, at hook is gage 3, and high side is gage 5 (Figure 1).

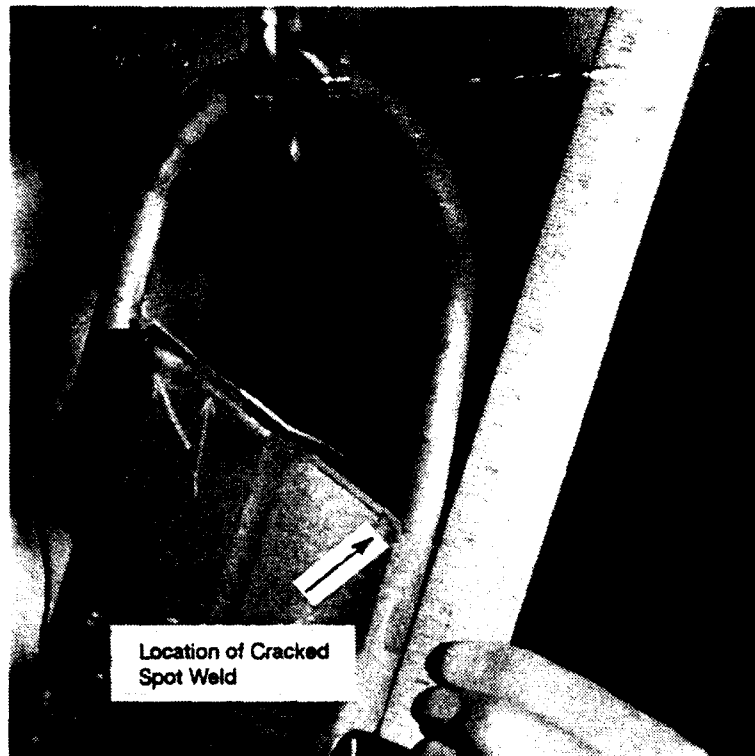
Because only the 3.2G loads were producing significant hysteresis, the second, more severe, test used only the 3.2G loads. An additional 5,332 cycles of the 3.2G load were applied, and the provision continued to function properly. At this point, the test was stopped to allow for NDE and metallographic examinations. The provision at the conclusion of the fatigue test is shown in Figure 10. A small crack was visually detected in one of the spot welds that holds on the top cover plate. The location of this crack is shown in Figure 10a.

(a) Deformed provision and location of cracked spot weld

The spot welds are used to hold the cover plate in position, but the cover plate is not a major load-bearing component. Therefore, this crack, confined to the spot weld, was considered to be unimportant.

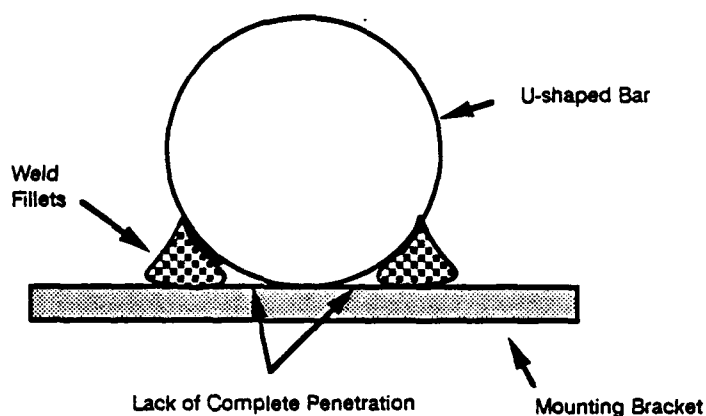
The fatigued provision was examined using radiography and the dye penetrant NDE techniques. The dye penetrant indicated the presence of a surface crack within an indentation caused by the loading chain. No other surface flaws could be detected on the bar. Radiography was used to examine the weld area. A weld on one side of the provision had undergone two welding passes. Though lack of complete weld penetration was observed, the weld showed no signs of fatigue failure. A schematic of the weld area as revealed by the radiographs is shown in Figure 11.

Figure 11. Schematic of welds as revealed by radiography.

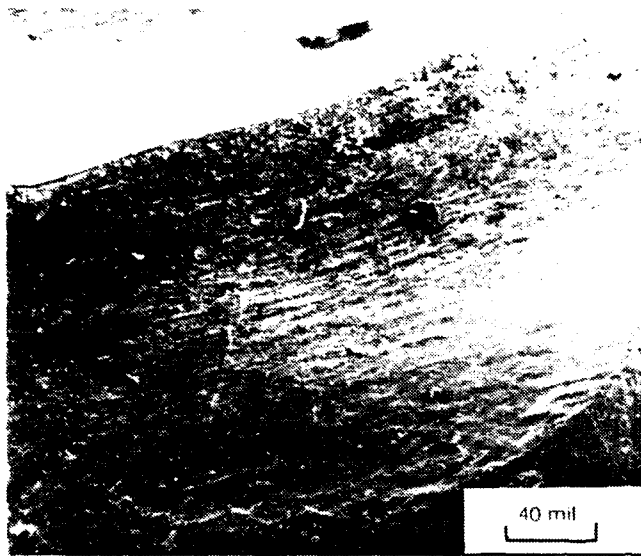
After the nondestructive examination of the fatigue test sample was complete, the region with the indentations and flaw was sectioned and examined by scanning electron microscopy. A crack was observed in the location specified by the dye penetrant test, and is shown in Figure 12 (a-c). The crack has a surface length of about 120 mils, but the depth of the crack cannot be determined from SEM photos. This sample was sectioned transverse to the crack near the center of its surface length. This sectioned view is seen in the optical micrographs of Figure 13. The depth of the crack at this point is about 40 mils, giving the crack front a semicircular shape. Further examination of the crack tip after etching the sample revealed a blunt crack tip. This demonstrates that the full crack depth was accurately measured from Figure 13. It was not determined when the crack was initiated during the fatigue test. Whether this was a critical crack that would have resulted in the eventual failure of the provision under continued cycling is also unresolved.

The formation of this crack within the indentation was somewhat unexpected, as the underside of the provision is nominally under compressive/compressive cyclic bending stresses. Possible mechanisms of formation include: (1) the interaction of residual tensile stresses from the indentation with the nominal bending stresses, causing tension/tension fatigue crack nucleation and propagation; (2) the formation of the crack upon initially indenting the material, with fatigue crack growth into the residually stressed region; and (3) the initiation and growth of the crack by contact fatigue. Other mechanisms may also be possible. Knowledge of how and when the crack formed is vital to assess its severity; both of these questions remain unanswered. It would require further experimental studies to separate out the possible mechanisms.

(a) Indentation on underside of bar where load is applied
(crack is not visible)

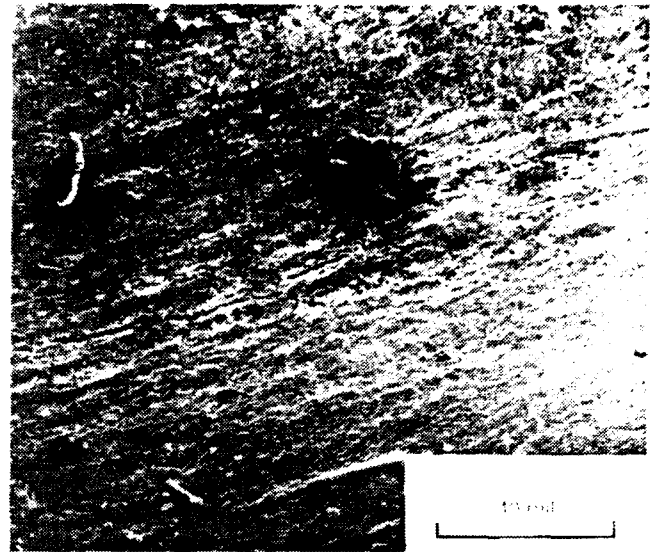
(b) Crack is just below foreign matter

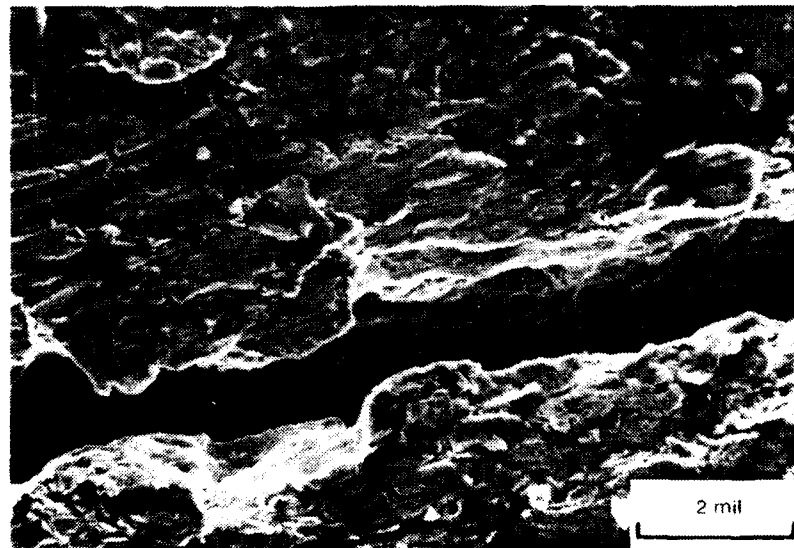
(c) Crack at higher magnification

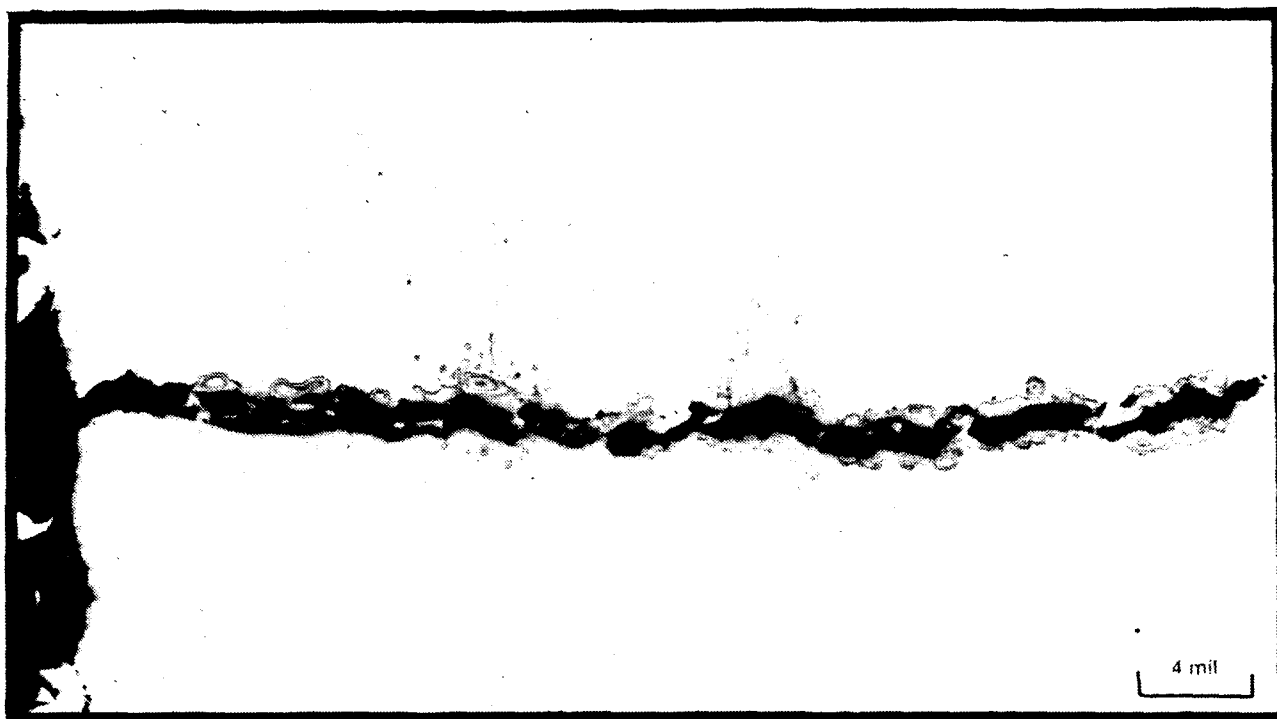
Figure 13. Crack in chain indentation sectioned transversely. Crack depth is approximately 0.040 in.

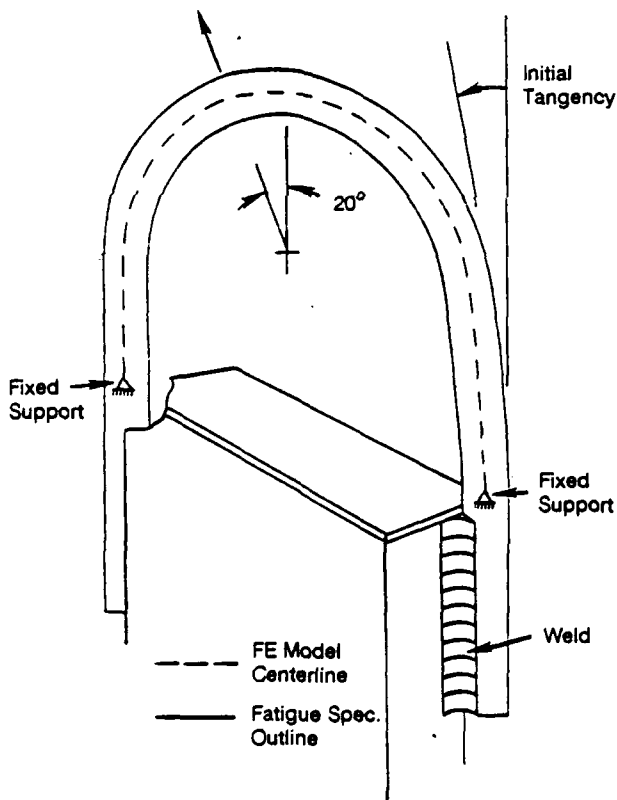
loads specified in Table 2, the model was unloaded to zero load to give permanent displacements and plastic strains. The amount of permanent displacement predicted by the FE model was compared to actual deformation by superimposing the zero load displacement fields of the case number 2 model against the actual deformation of the fatigue specimen as measured by projecting a photo of the deformed specimen. The case number 2 model and the fatigue specimen were both loaded to 8650 lb/20 degrees. Figure 14 shows the superimposed displacements of the FE model and the actual provision. Near-perfect correlation of the displacements is observed. The good agreement is directly related to the use of accurate material parameters, which were derived experimentally. The handbook value of yield strength for a 1020 cold-drawn steel is 30 percent less than the value observed in the tensile tests. The maximum residual plastic strain predicted by the FE model was approximately 5 percent for the case number 1 loading, near the point of concentrated loading.

Figure 14. Permanent set comparison between FE analysis and the fatigue specimen.

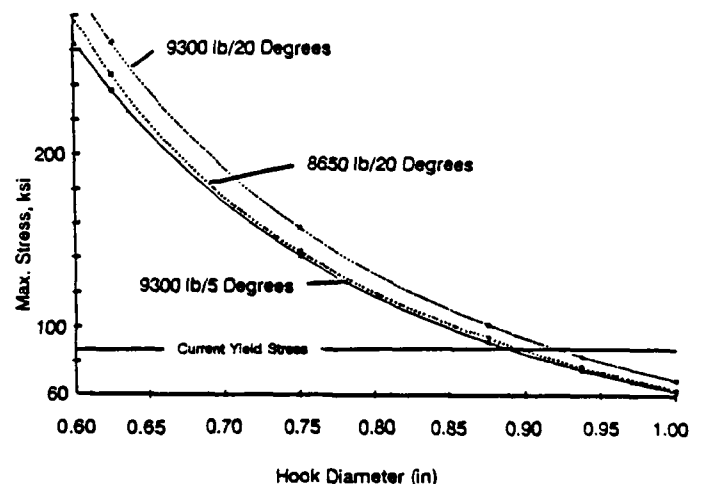
The FE model can also be used to specify the minimum bar (hook) diameter necessary to prevent plastic deformation. Linear-elastic analyses were performed for five different hook diameters. These analyses produce a maximum stress versus hook diameter curve (Figure 15) which can be used to determine the yield strength-diameter combinations required to avoid plastic deformation. Using the current material's yield strength of 87.5 ksi, a hook diameter of 0.925 inch would preclude yielding beyond 0.2-percent strain for the most severe case, case number 1. The present hook diameter is 0.625 inch.

Figure 15. Linear-elastic FE analyses giving maximum stress versus hook diameter for the three different load cases. The provision's yield strength is given by the horizontal line, which shows that a 0.925-inch diameter would be required to prevent significant yielding. The current bar diameter is 0.625 inch.

5. The finite element study showed excellent agreement with the actual deformation of the provision. To prevent significant yielding, a bar of 0.925-inch diameter with a yield strength of 87.5 ksi (the material currently used for the provisions) would be required. The differences between this analysis and the study by NCEL arose from the use of different material properties and the addition of plasticity to the finite element model. The properties used in the current study were measured on actual provision material, and are, therefore, more reliable than handbook values.
